SERVICE MGR.	X	
RECEPTION	X	
WORKSHOP	X	
PARTS	X	SUBJECT Poor Start or Non Start Related To Ignition Module Failure
MODEL	AFFECTED VEHICLES Range Rover LH 464554 to LH 651319-Discovery LJ 081991 to LJ 094035-Defender from LD 917122	
Range Rover Discovery/Defender		02/09/94 86/08/94/US

SUBJECT **Poor Start or Non Start
Related To Ignition Module Failure**

86/08/94/US

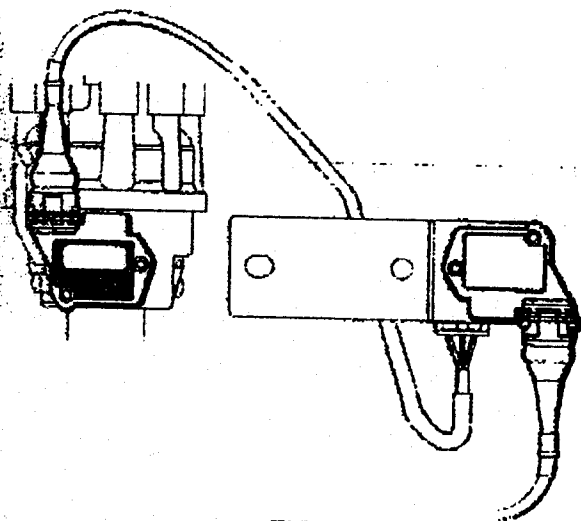
FIG 1

5) With the distributor correctly fitted, place the heatsink bracket assembly on the wing near the ignition coil. Connect the Econoseal connector of the service pick-up lead to the Econoseal connector attached to the heatsink bracket. (See fig 1)

6) Feed the 3-pin mini timer connector end of the lead under the front of the air cleaner housing and connect to the dummy module on the distributor. (See fig 1)

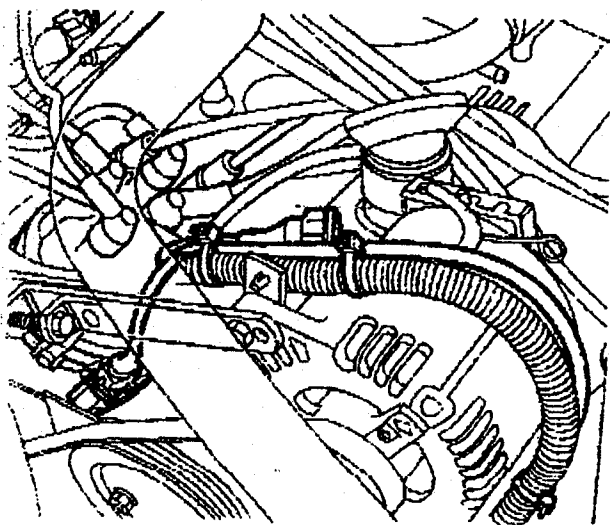
FIG 2

7) Cable-clip/tie wrap original engine harness connector back onto the harness. (See fig 2)

12) Cable tie the service pick-up lead to the engine harness. (See fig 2).

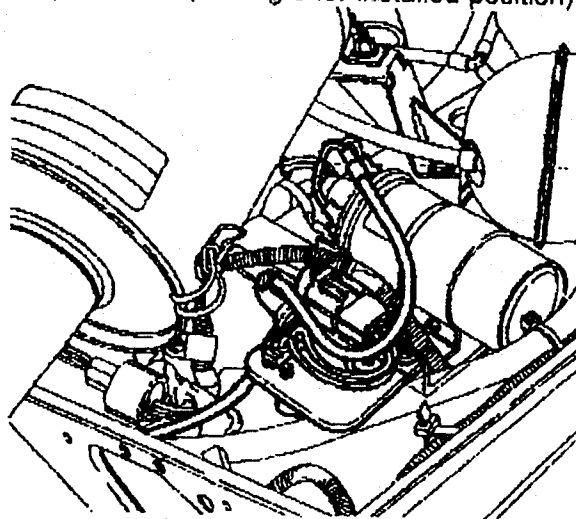
FIG 3

11) Fit the heatsink bracket beneath the coil. Re-mount the coil and heatsink bracket to the inner wing. Connect the two connectors of the fly lead to the ignition coil. (See fig 3 for installed position).
