SERVICE MGR.	X	
RECEPTION	X	
WORKSHOP	X	
PARTS	X	SUBJECT Poor Start or Non Start Related To Ignition Module Failure
MODEL	AFFECTED VEHICLES Range Rover LH 464554 to LH 651319-Discovery LJ 081991 to LJ 094035-Defender from LD 917122	
Range Rover Discovery/Defender		02/09/94 86/08/94/US

SUBJECT **Poor Start or Non Start
Related To Ignition Module Failure**

86/08/94/US

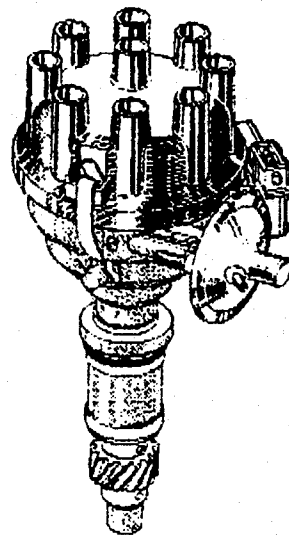
ILLUSTRATION

Some instances of poor start/non start have been reported on vehicles in the VIN range shown above. When this symptom occurs it can be as a result of failure by the module to control the coil primary current accurately. This leads to dwell angles in excess of 40 degrees at idle. In certain conditions the high current causes the coil to overheat and the insulating compound may leak from the unit, resulting in eventual failure to start. On Range Rover and Discovery models from the latter VIN's shown above, a remote mounted module has been introduced into production to reduce the likelihood of failure. Mounting the module remote away from the distributor reduces temperature, electrical interference and vibration, thus minimising the likelihood of failure. **NOTE:** Erratic dwell between 1000 and 3000 rpm (less than 30 degrees) does not signify module failure. For this condition refer to Bulletin 86/05/94.

For instances of excessive dwell angle at idle or ignition module/coil failure, fit the Service kit identified below and where coil leakage is experienced fit a new coil.

STC 1856 Service Kit.
PRC 6574 Coil

- 1) Remove the distributor assembly from the front cover assembly.
- 2) Remove the failed module from the side of the distributor.
- 3) Fit the dummy module (red in colour) which is supplied in the kit onto the side of the distributor ensuring that the blue connector terminals are a tight fit and using the original screws tighten to 1.2 Nm. **Care must be taken not to over torque the screws.**
- 4) Refit the distributor to the front cover **Ensure the engine is set to T.D.C and that the oil pump drive and rotor arm are in the correct orientation.**
